Recovery of Material Properties in Service-Degraded Gas Turbine Blades

Akihiro ITO¹, Yukio KAGIYA¹, Hirotaka WATANABE², Hagime TAKAGI²,
Daizo SAITO³, Yomei YOSHIOKA³, Hiroyuki ITO³ and Junji ISHII⁴

¹ Electric Power Research and Development Center, Chubu Electric Power Co., Inc.
20-1 Kitasekiyama, Ohdaka-cho, Midori-ku, Nagoya 459-8522, JAPAN

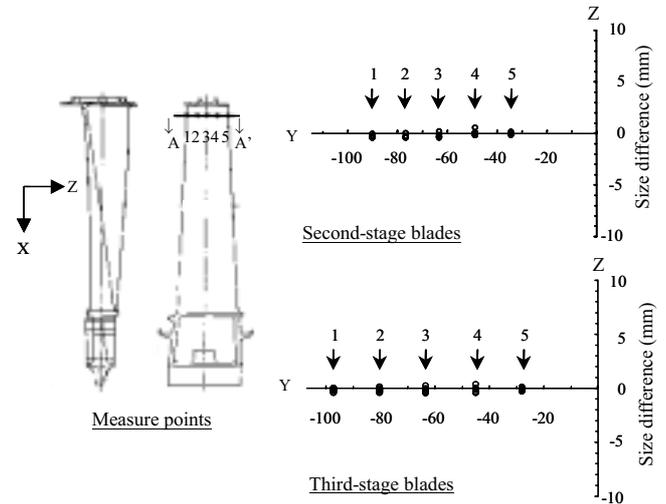
Fig. 2 Size difference between degraded and treated blades

The airfoil sections in the degraded blades of both stages were discolored in dark brown, and some wear was found at the tip shroud of the blades. But in other portions, there was no crack or any other damage, confirming that the treatment has prevented the occurrence of damages. Fig.2 shows the size difference between the treated and degraded blades of the second and third stages. There were slight deformation and torsion in the blades of each stage. A concern was expressed initially that the strain accumulated during operation would be released by this treatment, causing large deformation of sample blades. But, the experiment revealed that the measured deformation was within the design tolerance. Uncoated cooling holes of the second-stage blades were not closed due to the treatment.

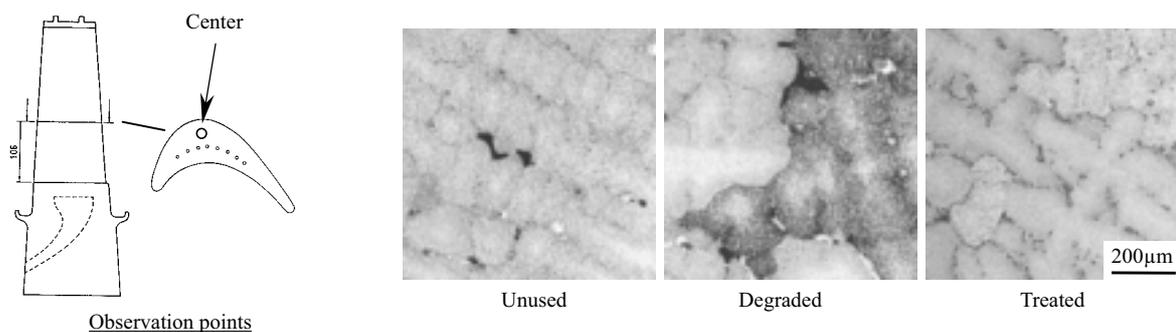
Figs.3 and 4 show the optical micrographs in the cross section of the second- and third-stage blades, respectively. Casting defects, indicated by arrow marks in these figures, observed in the unused and degraded blades were not found in treated blades of each stage. Neither the degraded

Fig. 3 Optical micrographs in the cross section of the second-stage blades

blades nor the treated blades had any crack in the cross sections observed. In addition, the treated blades did not feature strong microsegregation during casting. The oxide layer was detected in the degraded and treated blades of each stage. Furthermore, the γ' phase depleted layer was observed under the oxide layer. At the leading edge of second-stage blades, there was a corroded layer, indicating plate-like precipitates (AIN). The maximum depth of the oxide and γ' phase depleted layers detected in the degraded and treated blades of each stage was approximately 150 μm . The maximum depth of the same combined layer was approximately 100 μm on the cooling hole of the second-stage blades.

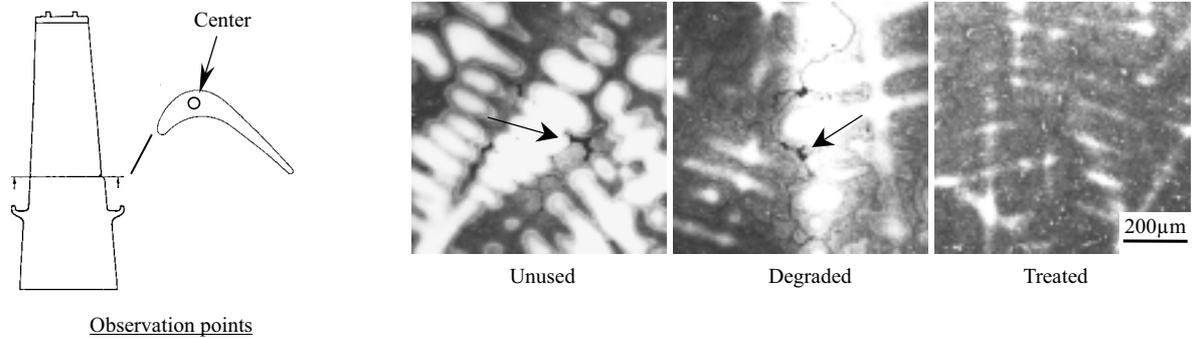
Fig. 4 Optical micrographs in the cross section of the third-stage blades

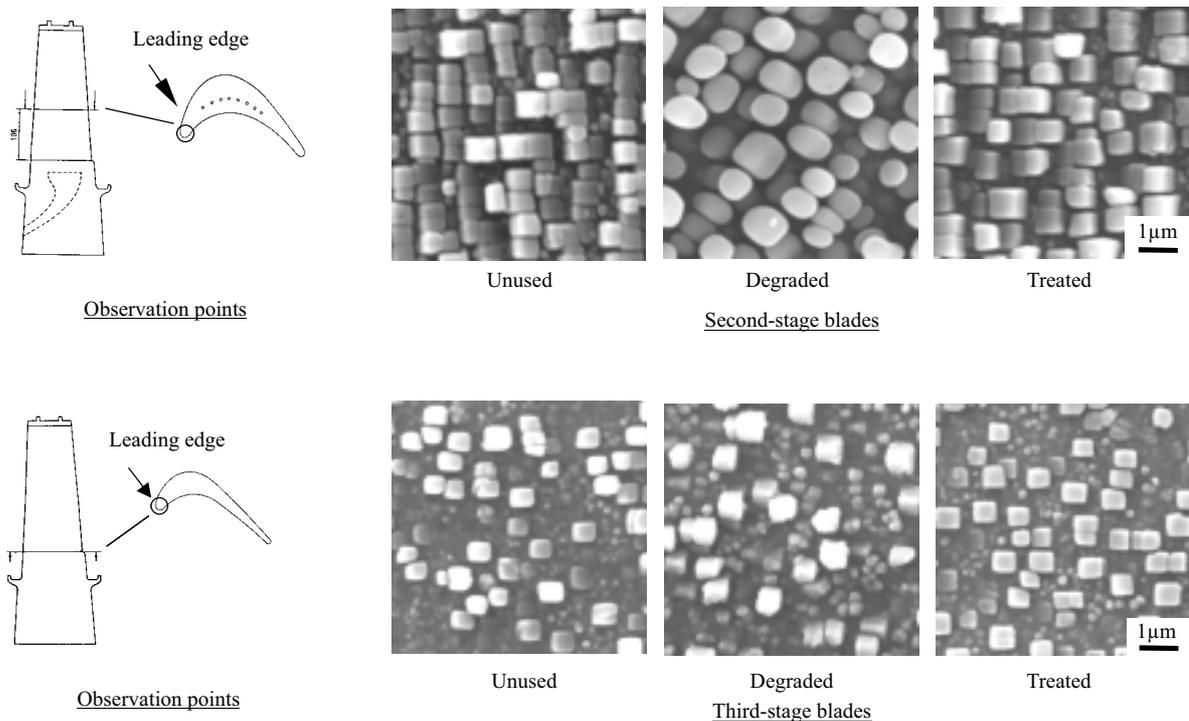
SEM micrographs in the cross section of the blades are shown in Fig.5. In the second-stage blades, the γ' phase coarsening and grain boundary γ' phase precipitation occurred at the leading edge. The treated blades featured a bimodal distribution of relatively large cuboidal and fine spherical γ' phase precipitates, which was the same microstructure as in the unused one. In addition, the grain boundary γ' phase precipitated was not observed in the treated blades, while that was found in the degraded blades. Because of applying the treatment, the grain boundary γ' phase would be

dissolved in the matrix. Thus, the microstructure of the degraded blades could be recovered to that of the unused one. In the third-stage blades, the γ' phase slightly coarsened at the leading edge of the degraded blades as shown in this figure. There was, however, no such a remarkable metallurgical change as that found in the second-stage degraded blades. The cuboidal γ' phase of the treated blade was almost uniform. Thus, microstructure of the treated blades was the same as that of the unused one. No creep voids was found in the degraded blades of both stages.

Fig. 5 SEM micrographs in the cross section of the second- and third-stage blades

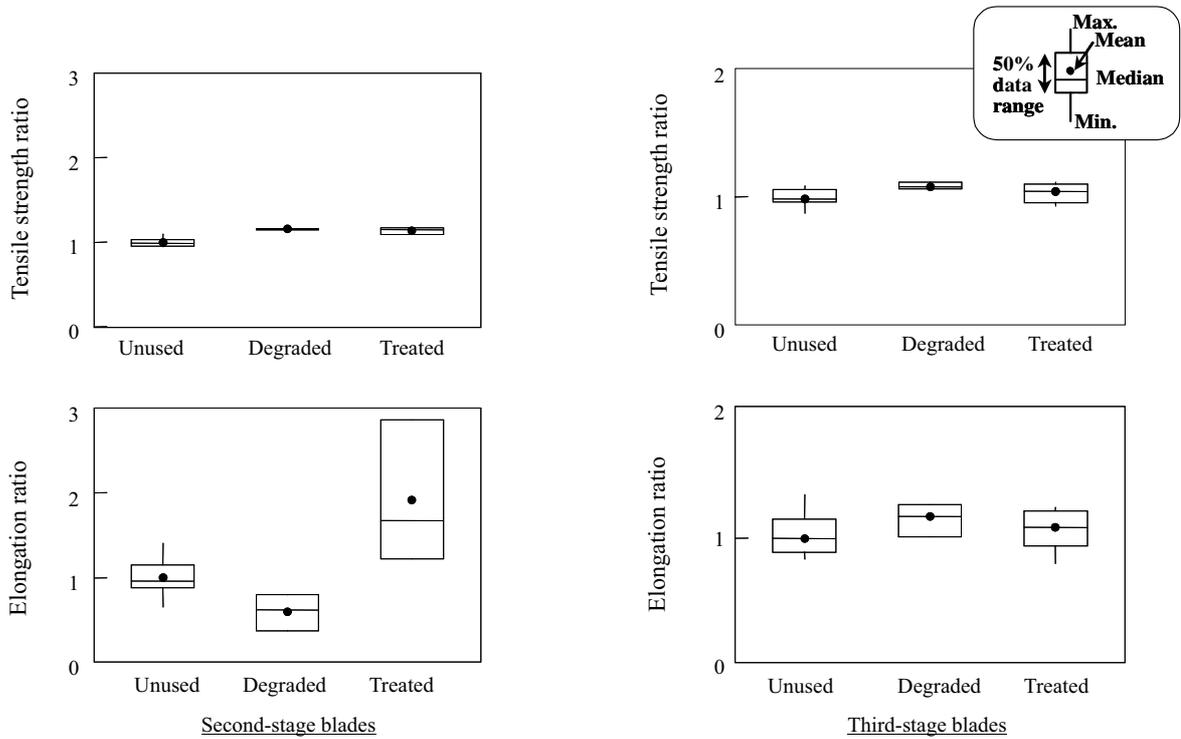
Tensile tests. Fig.6 shows the results of tensile tests carried out. The results of the degraded and treated blades are described in comparison to the mean values of the unused one. For the second-stage blades, the tensile strength and proof stress of the degraded and treated blades were equal to those of the unused one. In terms of ductility, the degraded blades were inferior to the unused one, while the treated blades were superior to the degraded ones. In other words, the tensile properties of the degraded blades were recovered by applying the treatment to a degree of the unused one. For the third-stage blades, the tensile

Fig. 6 Tensile properties of the second- and third-stage blades

strength and proof stress of the degraded and treated blades were almost the same as those of the unused one, so it can be said that there was no degradation in tensile properties of the third-stage blades due to their operation and/or the treatment.

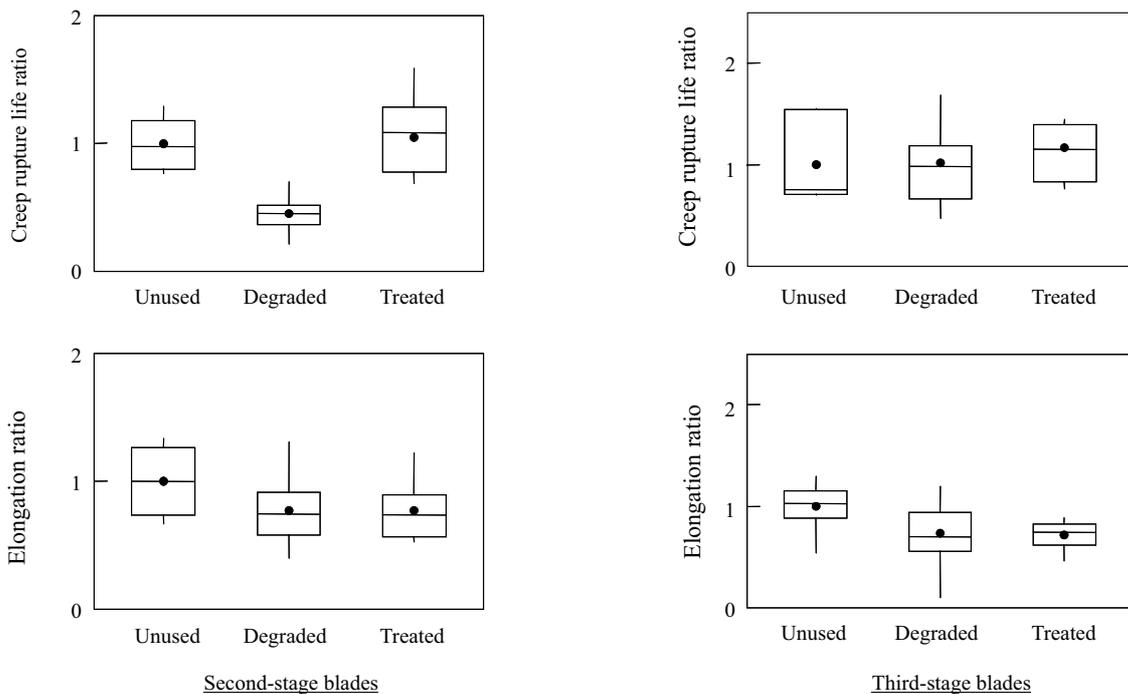
Creep rupture tests. Fig.7 shows the results of creep rupture tests performed, comparing the results of the degraded and treated blades with the mean values of the unused ones. For the

second-stage blades, creep rupture life of the degraded blades was shorter than that of the unused one, while that of the treated blades was equal to that of unused one. Thus, it could be said that the treatment recovered the creep rupture life of the degraded blades to a degree close to that of the unused one. In addition, the minimum values of the ductility have been improved in the course of the treatment, although the mean values of the treated blades were slightly inferior to the unused one. For the third-stage blades, there

Fig. 7 Creep properties of the second- and third-stage blades

was no remarkable degradation in the mean values of creep rupture life and ductility for the degraded blades, as compared to the unused one. While creep properties featured a decline in the minimum values, those minimum values have been improved by the treatment.

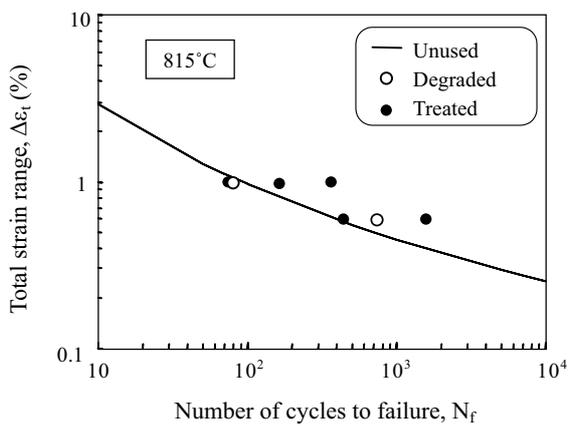
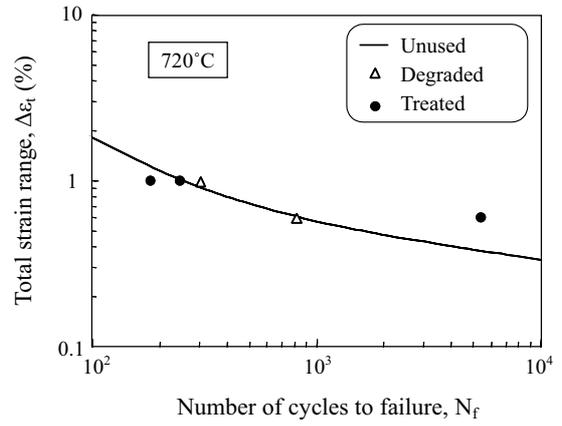
Fig. 8 Low-cycle fatigue life of the second- and third-stage blades

Low-cycle fatigue tests. Fig.8 shows the results of the low-cycle fatigue tests performed, comparing the results of the degraded and treated blades with the mean values of the unused ones. Low-cycle fatigue life in degraded and treated blades of each stage indicates the same as that of the unused ones, except when total strain ranges are large. In other words, there was no degradation in fatigue life of the sample blades due to the operation and/or the treatment.

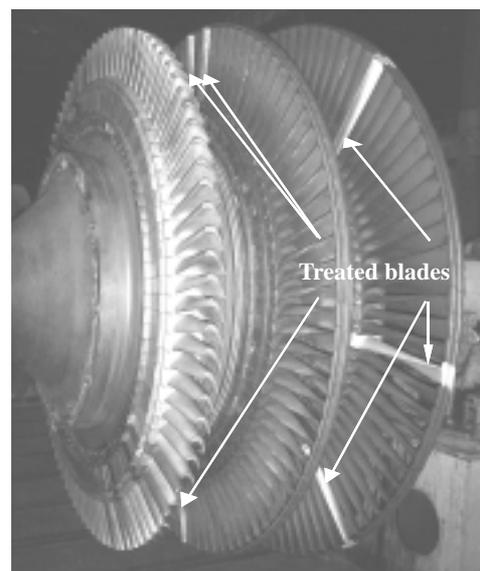
the appearance of the treated blades installed in the turbine rotor before trial operation. For about two years, from the restart to September 2001, no troubles or irregularity has been experienced. Then, we conducted the follow-up damage inspection for every treated blade after trial operation.

Fig. 9 Appearance of the treated blades installed in the turbine rotor before trial operation

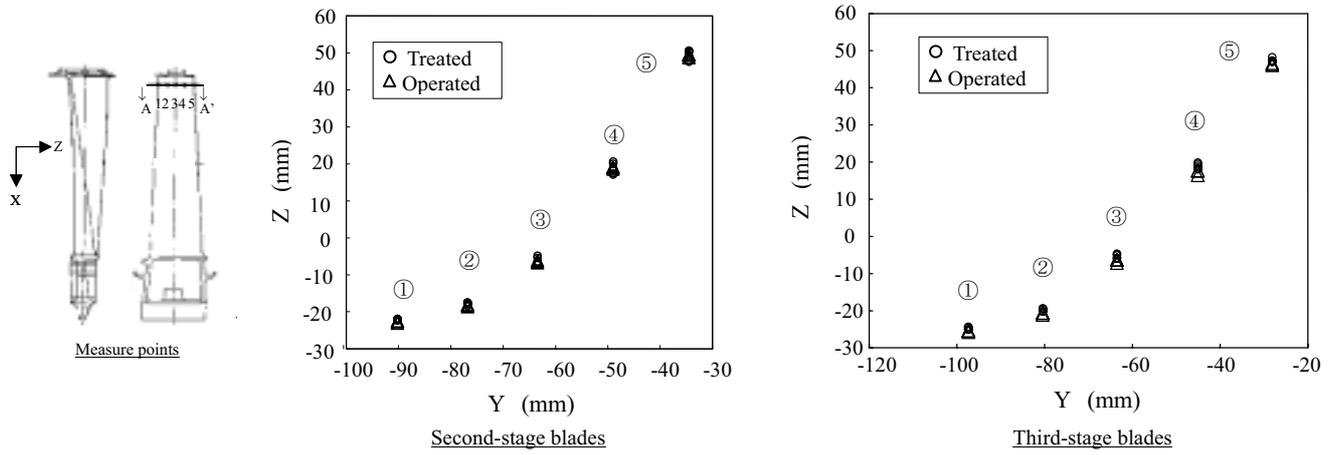
Fig. 10 Results of 3D size measurement of the operated and treated blades

Fig.10 shows the results of 3D size measurement for the treated and operated blades. Note that measure points are the same position of airfoil section shown in Fig.2. The operated blades of each stage almost did not differ dimensionally from the treated blades, and no deformation and torsion were detected in the airfoil section.

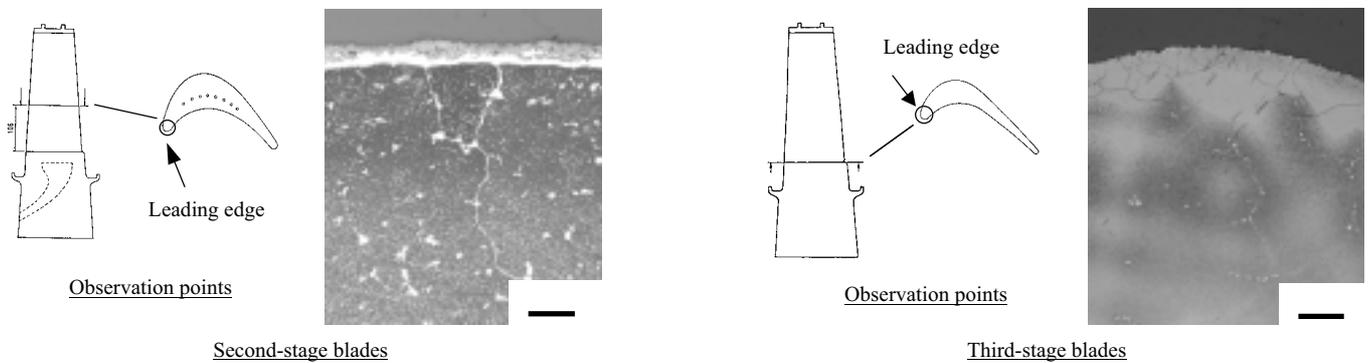
Microstructural observation. Fig.11 shows the optical micrographs in the cross section. No cracks were observed

in any cross section of the each-stage blades. And, no casting defects were detected in the each-stage blades, as in the case of the treated blades. Similarly to the degraded and treated blades, the surface of the operated blades had a corroded layer, consisted of the oxide and γ' phase depleted layers, but there was no plate-like precipitates (AlN). The maximum depth of the corroded layer was about $50\mu\text{m}$ at the tip shroud in the second-stage operated blades, while the maximum depth for the third-stage blades was approximately $20\mu\text{m}$. The maximum depth of the corroded layer on the cooling hole of the second-stage blades was approximately $100\mu\text{m}$, as in the case of the degraded and treated blades.

Fig. 11 Optical micrographs in the cross section of the operated blades

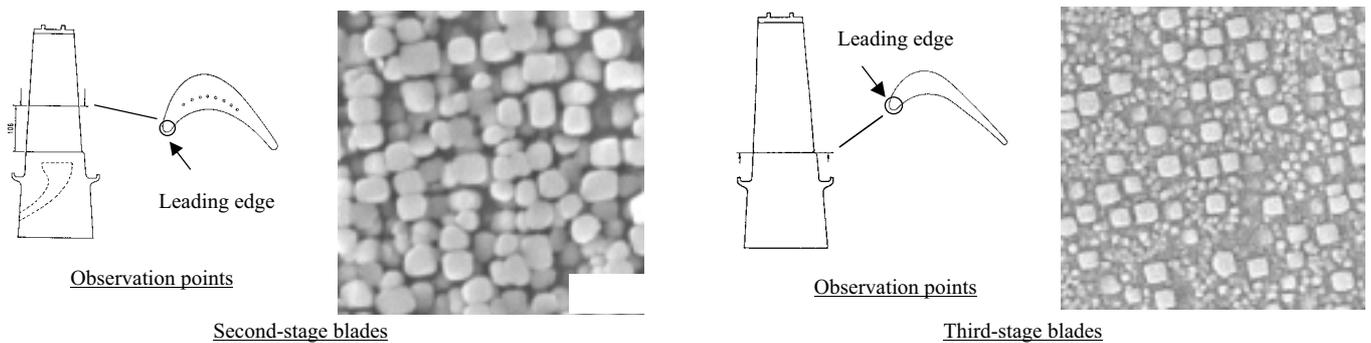
SEM micrographs in the cross section are shown in Fig.12. Coarsening of the cuboidal γ' phase and disappearance of the fine spherical γ' phase were occurred at the leading edge in the

Fig. 12 SEM micrographs in the cross section of the operated blades

second-stage blades. The film-like grain boundary γ' phase precipitates were detected, but no creep void was found. The third-stage blades featured a slight γ' phase coarsening at the leading edge, as shown in Fig.12. Metallurgical changes were not as remarkable as those in the degraded blades.

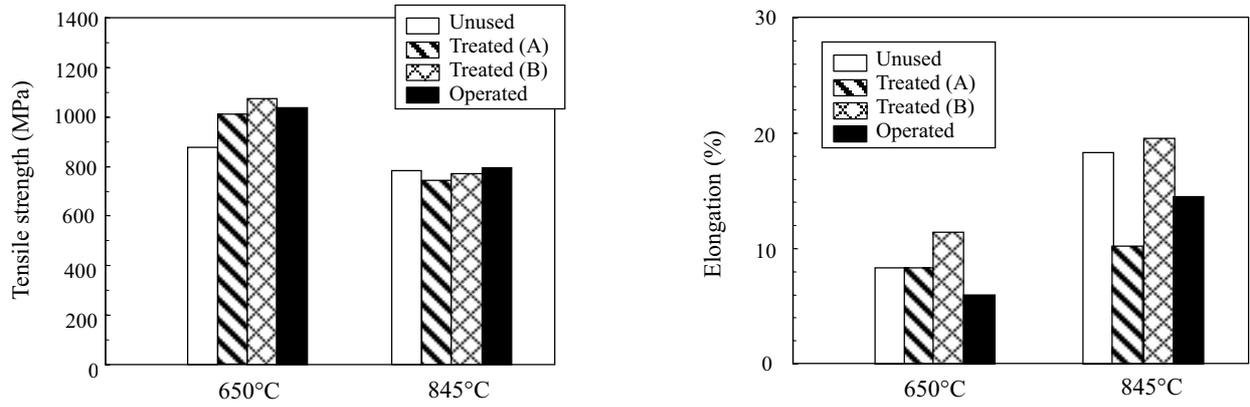
Fig. 13 Tensile properties of the second-stage operated blades

Tensile tests. Figs.13 and 14 show the results of tensile tests performed at room and high temperatures on the second- and third-stage blades, respectively. The tensile properties of the operated blades are almost equal to those of the unused and treated blades. Thus, there was no degradation detected in tensile properties of the operated blades.

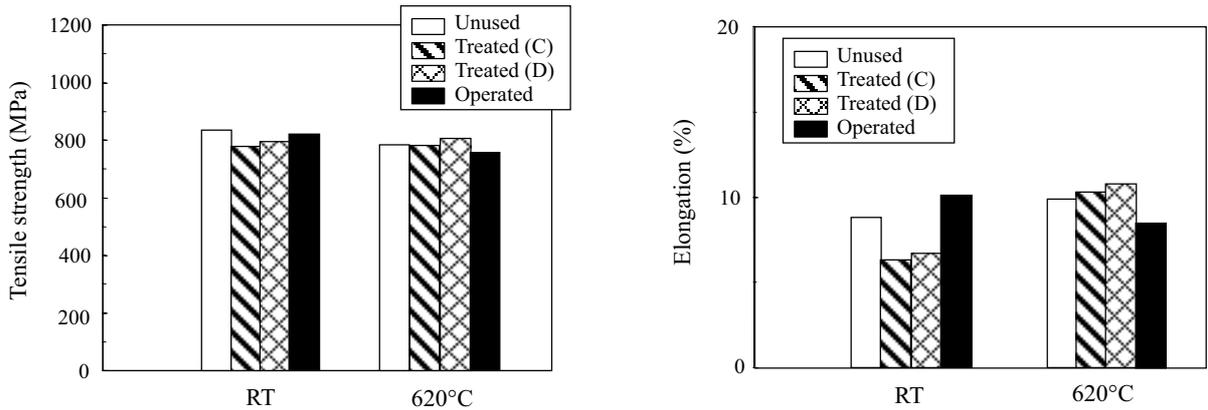
Fig. 14 Tensile properties of the third-stage operated blades

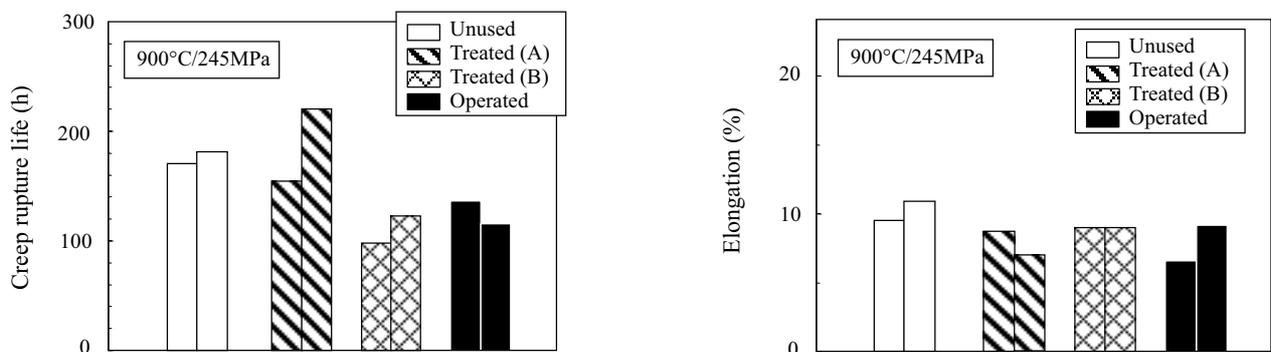
Creep rupture tests. Figs.15 and 16 show the results of the creep rupture tests performed at 900°C/245MPa and 825°C/245MPa on the second- and third-stage blades, respectively. The creep rupture life of the operated blades was slightly lower than that of the unused blade, but various creep properties were within the data range of the treated blades. Thus, there was no further degradation in those properties due to trial operation.

Fig. 15 Creep properties of the second-stage operated blades

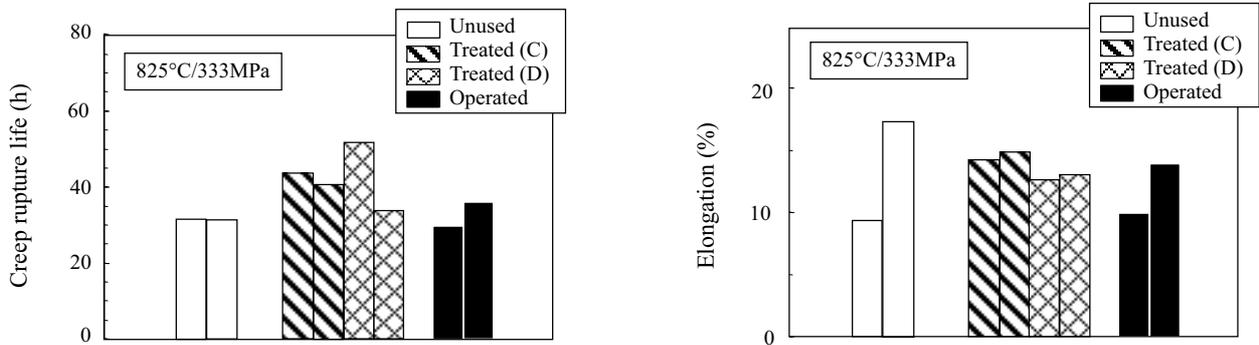
Fig. 16 Creep properties of the third-stage operated blades
