Recovery of Material Properties in Service-Degraded Gas Turbine Blades

Akihiro ITO¹, Yukio KAGIYA¹, Hirotaka WATANABE², Hagime TAKAGI²,
Daizo SAITO³, Yomei YOSHIOKA³, Hiroyuki ITO³ and Junji ISHII⁴

¹ Electric Power Research and Development Center, Chubu Electric Power Co., Inc.
20-1 Kitasekiyama, Ohdaka-cho, Midori-ku, Nagoya 459-8522, JAPAN

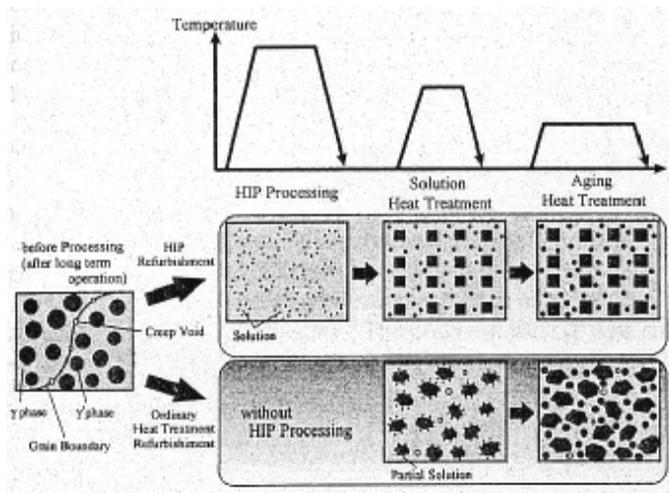
As shown in Fig.1, HIP could make the coarsened spherical γ' phase dissolve in the matrix and eliminate creep voids and casting defects of the degraded materials (Honma, 1999). Thus, HIP followed by the solution and ageing heat treatment could recover the microstructure of the degraded materials. Applying high temperature exceeding the γ' phase solvus temperature, and high

Fig. 1 Effects of HIP-combined heat treatment for degraded materials (Honma, 1999)
