老朽タンカー対策の策定に 関する調査研究（SPT）

（2005年度報告書）

財団法人 日本船舶技術研究協会

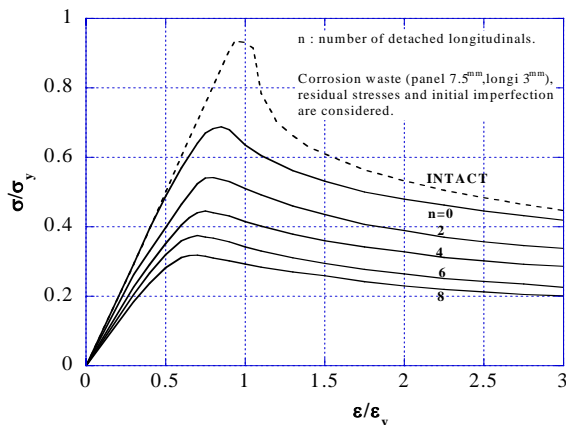
図 2.2.1 Compressive strength of deck structure (from the report of Nakhdoka casualty)

この中で、デッキロンジの甲板からの脱落は、ナホトカ号事故解析²⁾の結果(図 2.2.1)に示されるように、急激な船体強度の減少をまねくものであり、船体折損事故のトリガーに成り得ると考えられる。また、デッキ裏のロンジ接合部はタンカー構造においても腐食の激しい部位であり、上記「ダブルハルトンカーの構造の経年劣化に関する研究」の中で実施した修繕WGにおける検討においても、修繕の専門家より、メンテナンスの悪い船においては、図 2.2.2 に見られるような腐食状態が散見されるとの意見を得た。

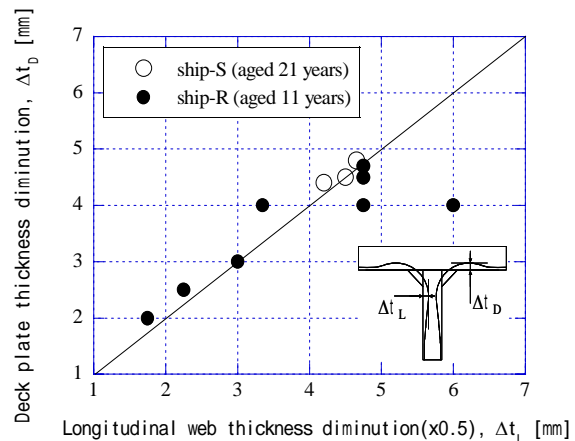
図 2.2.4 甲板ロンジ接合部の局部腐食データ

また、実際にV字折損を起こした船舶（事故発生年月：昭和51年9月、Pre-MARPOLタンカー）から採取したサンプルより甲板と甲板ロンジそれぞれの隅肉溶接近傍の局所衰耗量を計測した結果をプロットしたものが図2.2.4であり、この図より上甲板の衰耗量 t_D とロンジ片面の衰耗量 t_L がほぼ等しいとの推定を行った。

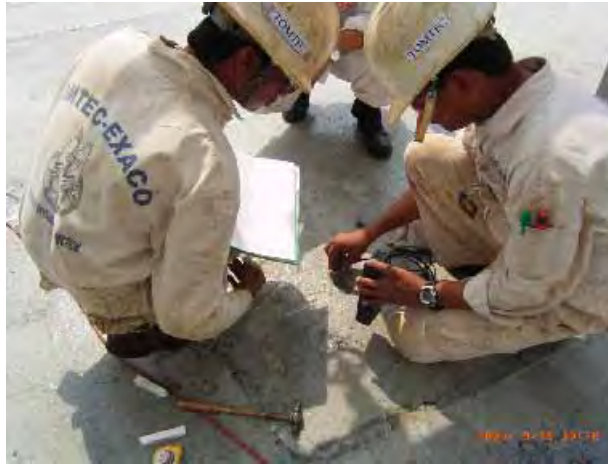
図 2.2.7 写真 計測風景

検査箇所すべてについて、測定要領にしたがって、板厚計測を実施することができた。CAS 対象タンカーに適用することは可能であるといえる。

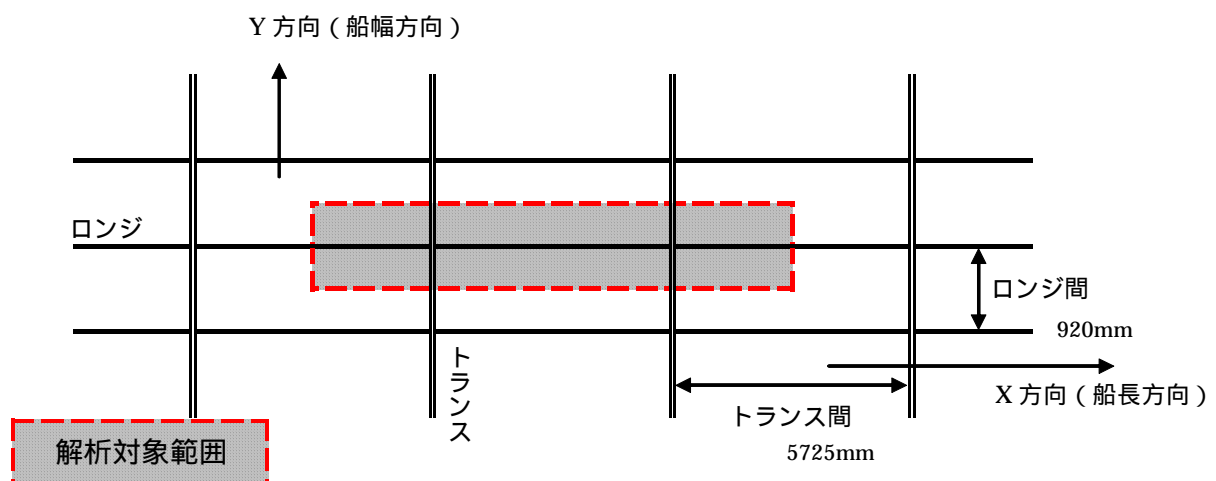
図 2.3.1 甲板構造のモデル化範囲

甲板と甲板ロンジの溶接部の健全性が、甲板強度に及ぼす影響を構造解析により確認した。対象モデルは、今年度調査を行なった 2.2 の SH-VLCC に倣い、フレーム間 5725mm、ロンジ間 920mm、甲板 (t=23mm) + アンクル材 (400*100*13*18)、溶接脚長 5mm の防撓パネルとした。解析対象範囲は図 2.3.1 のとおり設定した。

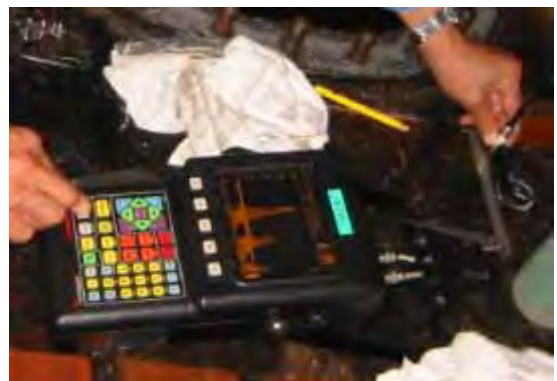
図 3.2.2 B1-B2 計測を用いた板厚計測

この様な、B1-B2 計測では、B2 エコーは多重反射エコーであるため B1 エコーよりも強度的に弱く、また、底面が腐食等で平滑度が低い場合にはさらに弱くなるため、計測を行う際には、図 3.2.2 にあるような超音波の計測波形を表示できる測定器を用いて計測波形を確認しながら測定することが望ましい。

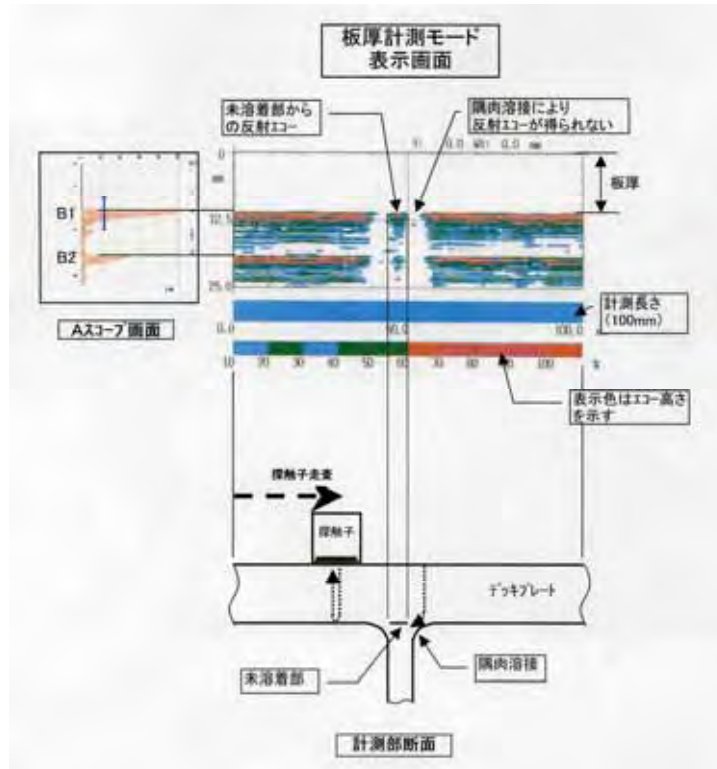
図 3.2.3 接合部近傍の連続計測

図3.2.3は、連続走査を行った際に、計測されていた底面エコーが隅肉溶接部に来ると反射角度が変わるため垂直探触子では、検出されなくなり、未溶着部でまた底面エコーが検出され、反対側の隅肉溶接部でまた検出されなくなり、溶接部が終わった後にまた検出される、と言うことを示している。このため、健全なロンジでは、連続走査により簡単に未溶着部を検出することが出来る。(実船調査においても塗膜上からの計測であっても簡単に未溶着部を検出することが出来た。)

今回DE49に提案した甲板ロンジ接合部検査法は、板厚の計測データより隅肉溶接部の腐食衰耗量を推定する手法だが、まず、計測に当たり、隅肉溶接部の未溶着部を検出する必要がある。未溶着部の検出には、接合部近傍を溶接線と直角方向に連続的に探触子を走査し、その計測波形を追うことで検出できる。実際に実船調査において連続計測したデータを図3.2.3に示す。

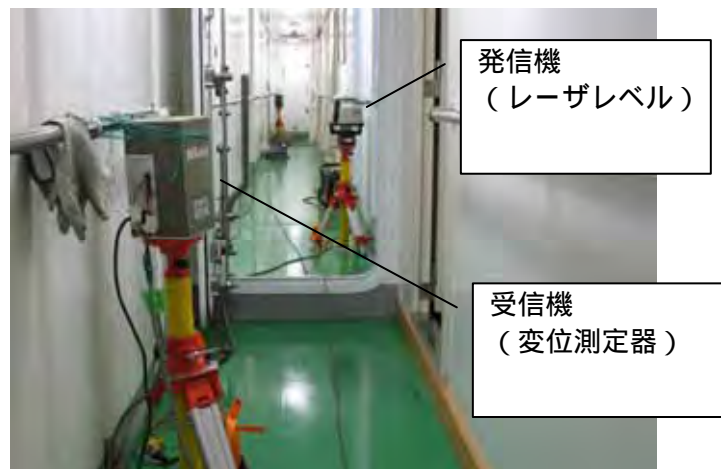
図 3.2.6 たわみ計測の例

3次元写真計測技術を適用して、船体のたわみを測る方法が考えられる。これは、構造物が図面どおりに完成されているかどうかを確認する手段として開発された技術で、この技術を応用することで船体のたわみを計測できる可能性がある^{2) 3)}。この手法の利点は、船上で計測する必要が無いことで、特に PSC の限られた時間と作業範囲においては、有効な手段と考えられる。
